NBS CIRCULAR 550

**Mechanical Failures
of Metals in Service**

For many years the National Bureau of Standards has made examinations of metal parts that have failed in service for evidence bearing on the causes of failure. Thirty-five such cases, representing the most frequently observed types of failures are described, and the factors of design, fabrication, or use contributing to these failures are presented. The characteristics by which the various types of fractures can be recognized are discussed, and recommended precautions that should be observed to reduce mechanical failures of metals in service are included.

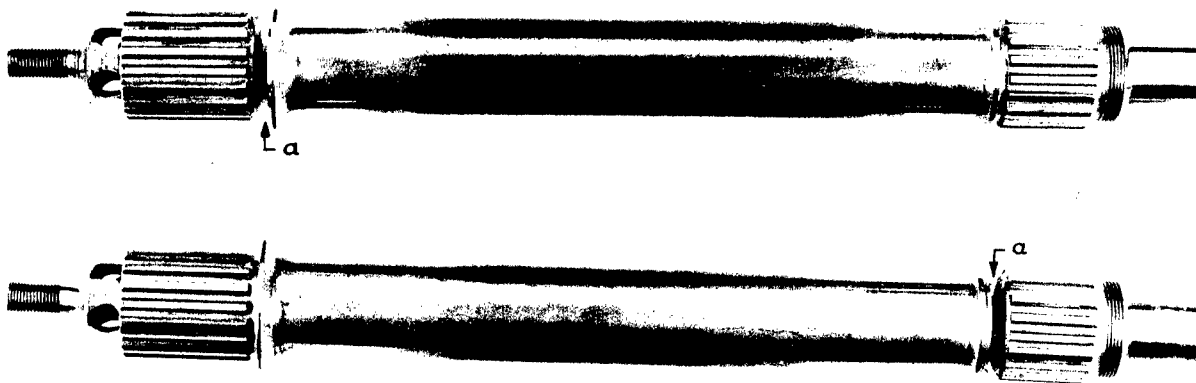
sudden stopping of the engines. The shafts apparently failed owing to the excessive torque applied to them when the propellers were stopped by impact with the ground. This example is included to show the type of fracture found in ductile materials subjected to torsion. The absence of deformation remote from the fracture is due to the stress concentrating effect of the grooves and the high rate of loading. This fracture might easily have been mistaken for fatigue, but on close examination of the fracture surfaces it was evident that the metal had been extensively deformed in shear.

FIGURE 3.1. *Accessory drive shafts fractured at arrows a*

The geometry of the parts and the high rate of loading localized the deformation in the grooved portions of the shafts, which were nearly identical at the two ends. The torsion load caused no dimensional change in the shaft before fracture such as a tension load would have caused. $\times \frac{1}{2}$.

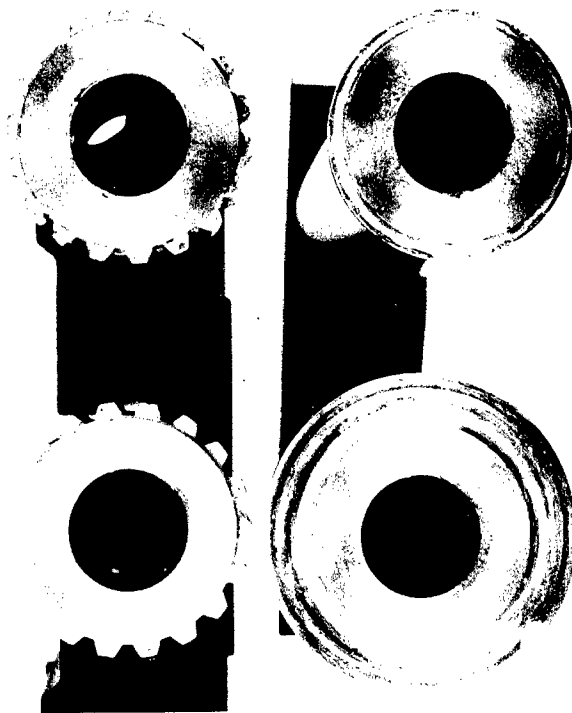
FIGURE 3.2. *Surfaces of the fractures.*

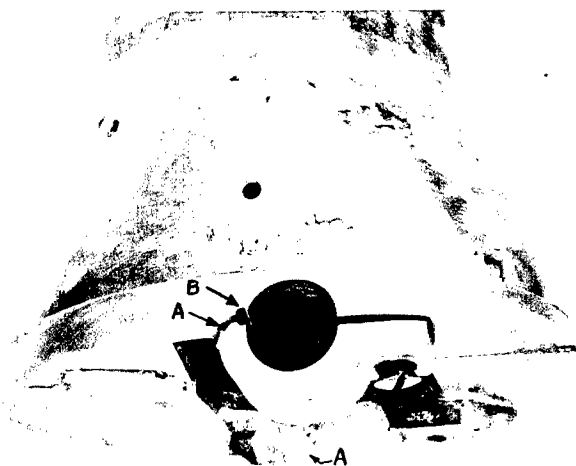
at the back of the clamp acted as points of stress concentration that would reduce the strength of the relatively brittle casting. In addition, the casting was of poor quality, containing numerous voids.

FIGURE 4.1. *Aluminum-alloy ankle casting.*

The fractures, A, occurred at the back of the clamp where the key grooves, B, reduced the cross section. $\times 1$.

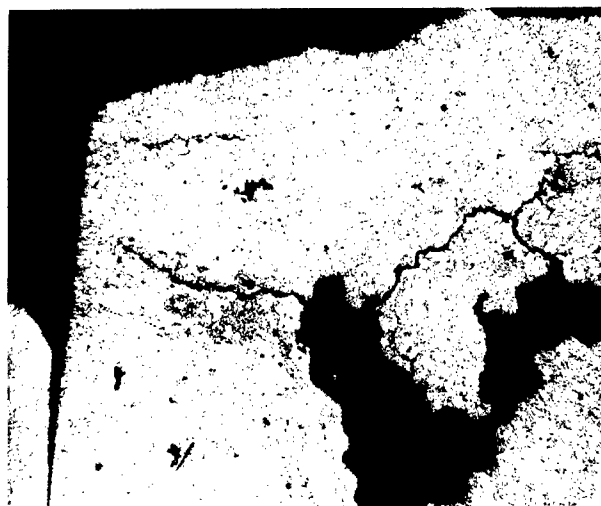
FIGURE 4.2. *Section perpendicular to the fracture (top) showing porosity, which greatly reduced the strength of the casting.*

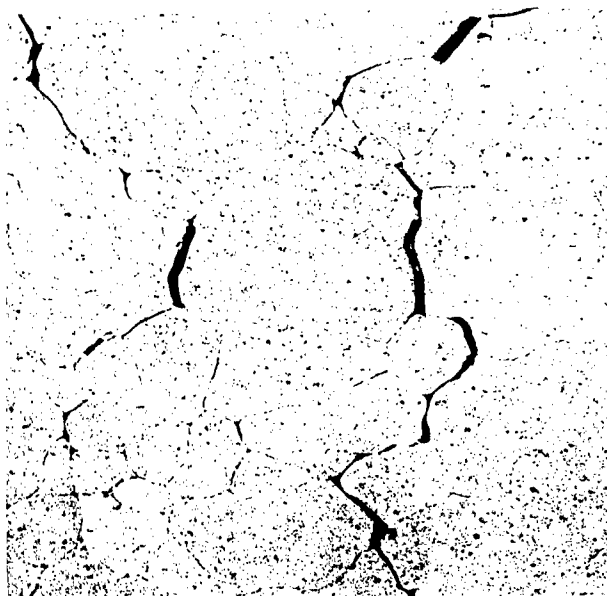
FIGURE 5.2. Microstructure on a longitudinal section of the tube near the fracture shows numerous intergranular cracks that are typical of material that has been subjected to stress at high temperature.

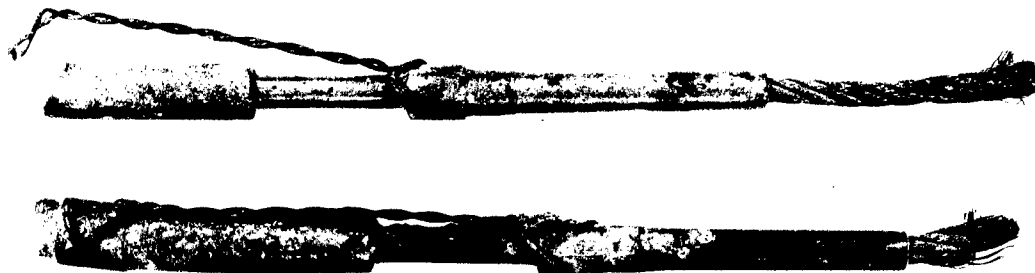
Case 6: Turnbuckle from aircraft control system (brass). Removed from an airplane that had been involved in an accident. It was evidently not the primary failure. The part had broken while heated to a very high temperature. The fracture surface shows extremely coarse grains and little ductility. The temperature at the time of failure was sufficiently high to reduce the strength of the grain boundaries in the metal, which resulted in fracture, with little or no ductility.

FIGURE 6.1. Parts of two broken turnbuckles removed from a crashed airplane. $\times 1$.

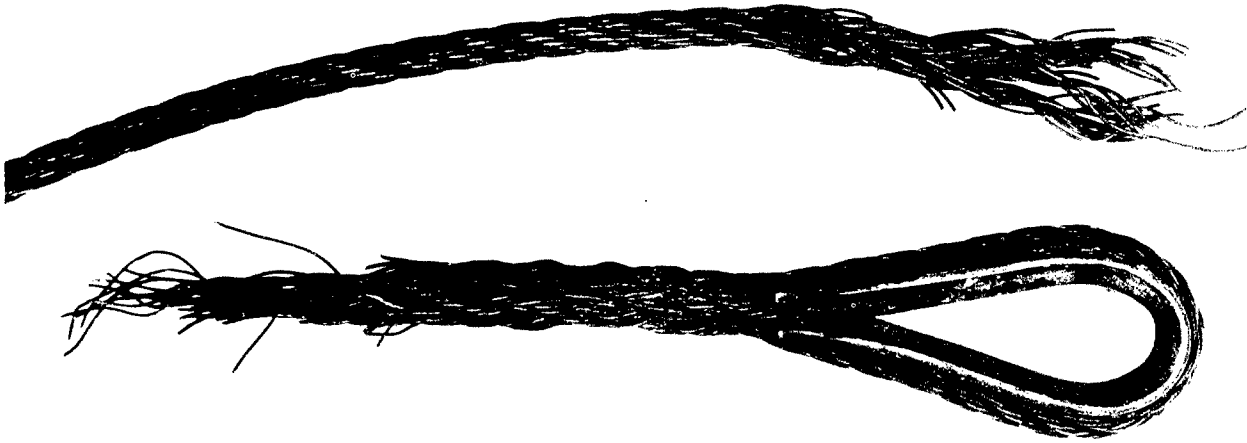
completely alter the microstructure, resulting in much lower strength. This weakened portion of the wire was unable to withstand the normal applied loads and failed in a ductile manner.

FIGURE 7.1. Broken rudder cable. $\times 3$.

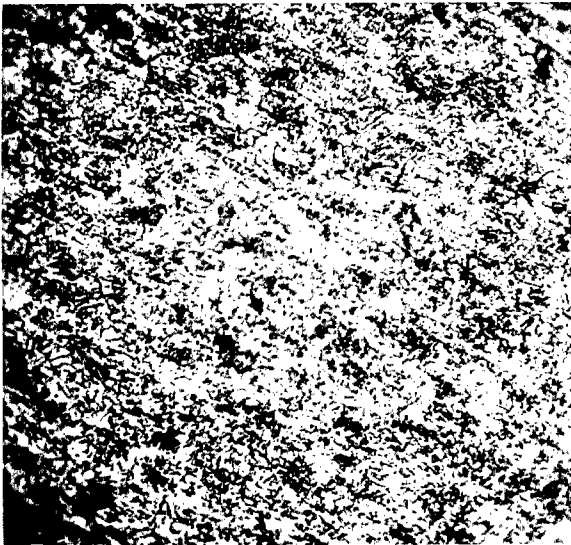
FIGURE 7.2. Microstructure of a longitudinal section of a wire near the fracture indicates that this portion of the cable had been heated sufficiently to spheroidize the carbides and reduce the strength of the cable.

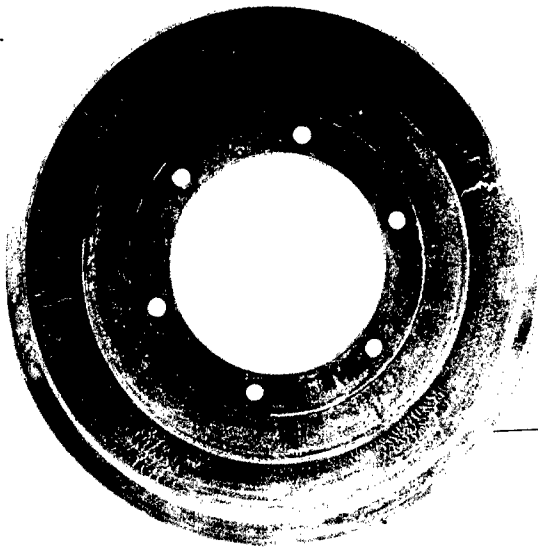
iron to martensite in some spots. As martensite occupies more volume than pearlite, the transformation set up high internal stresses in the metal, which, combined with the applied stress, were sufficient to cause cracking adjacent to the transformed areas. This type of cracking is often referred to as heat checking.

FIGURE 9.1. *Cracked brake drum, as received.*

The cracks are easily visible because of the brake lining material that had been scraped off and forced into them. $\times \frac{1}{4}$.

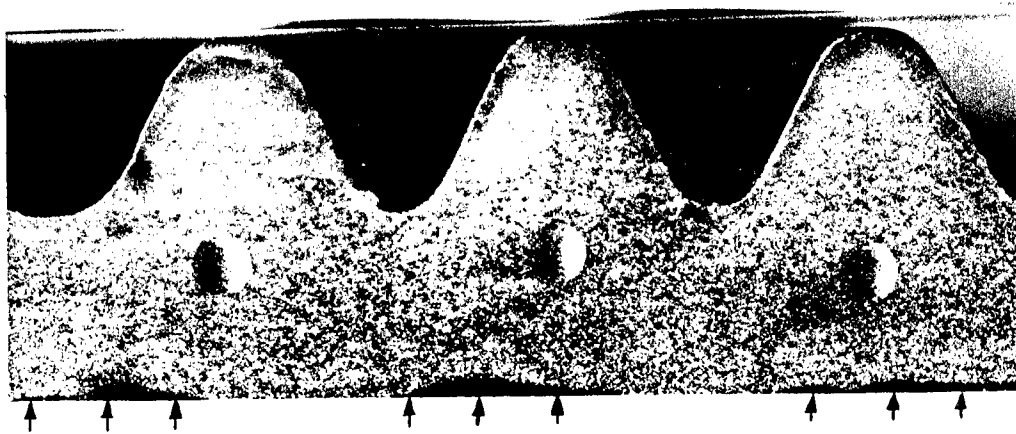
FIGURE 9.2. *Etched section of drum showing numerous transformed areas (dark) indicated by arrows along the inner surface at bottom.*

The hardness of the original material was 265 Vickers, whereas that in the dark areas was as high as 450 Vickers. $\times 2$.

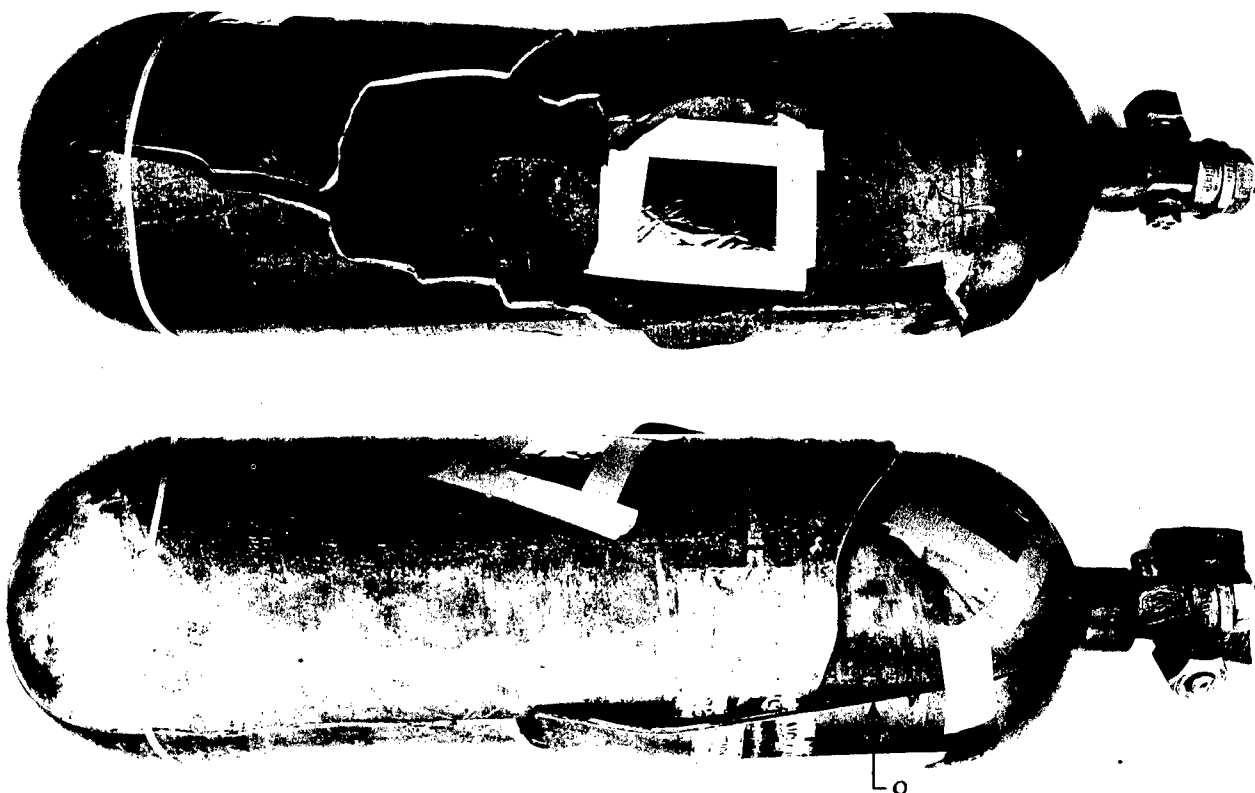
FIGURE 10.1. *Appearance of exploded cylinder with pieces fitted approximately in their original positions.*
By following the indications of the markings on the fracture surfaces, the origin of the fracture was located at arrow O. $\times \frac{1}{4}$.

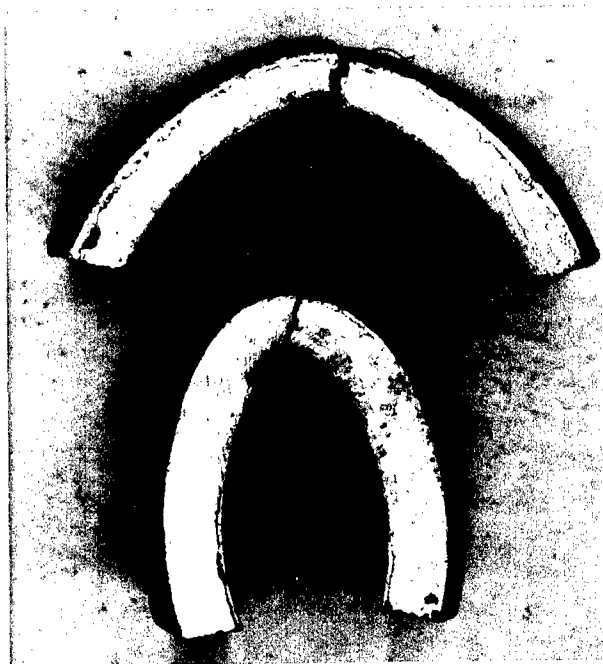
FIGURE 11.3. Bend tests on sections cut from the eye of unused bearings, showing the difference in ductility in different directions.

Top, section cut from top of eye so the bending stress was transverse to the direction of rolling. Bottom section from side of eye. $\times 2$.

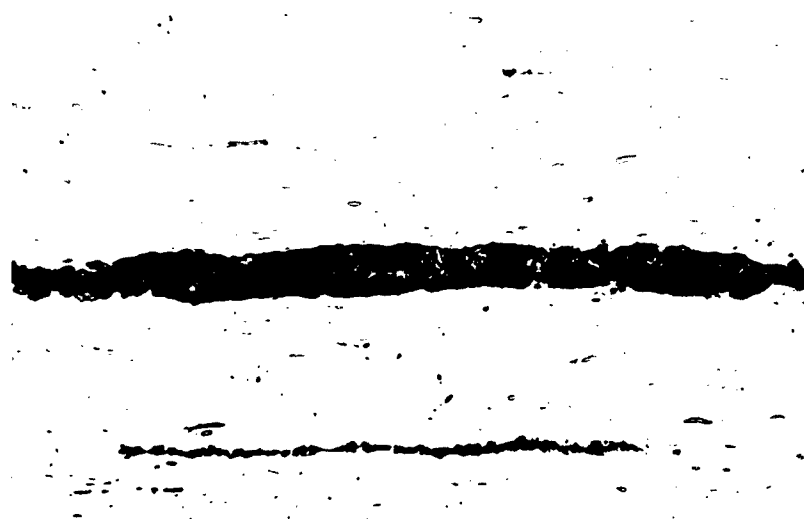
FIGURE 11.4. *Large inclusions observed on a longitudinal section of the steel*
The numerous small inclusions shown in this micrograph are typical of those found on all sections examined. No etch. $\times 100$.

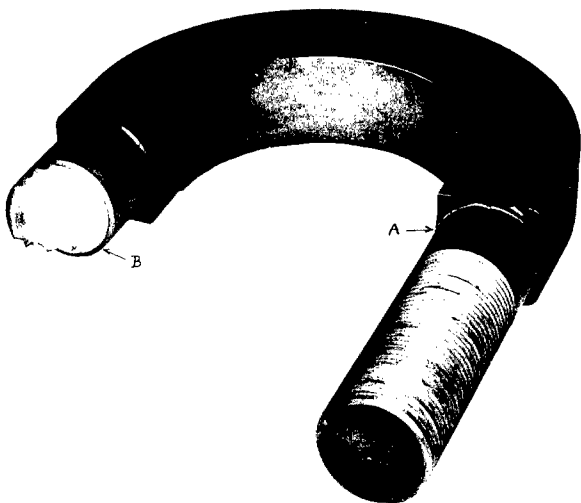
stress at fracture was only 30,000 lb/in.² It was found that the piece contained numerous intergranular cracks, probably due to improper forging practice or heat treatment. In addition, the hardness and strength of the steel were much higher than that specified, (45 Rockwell C compared to a specified value of 34) with consequent greater brittleness. The combination of these factors reduced the strength of the part much below that of sound material of lower hardness.

FIGURE 13.1. *Fractured yoke with the initial fracture, A fitted together.*

The fracture at B resulted from the eccentric loading after the initial fracture. $\times \frac{1}{16}$.

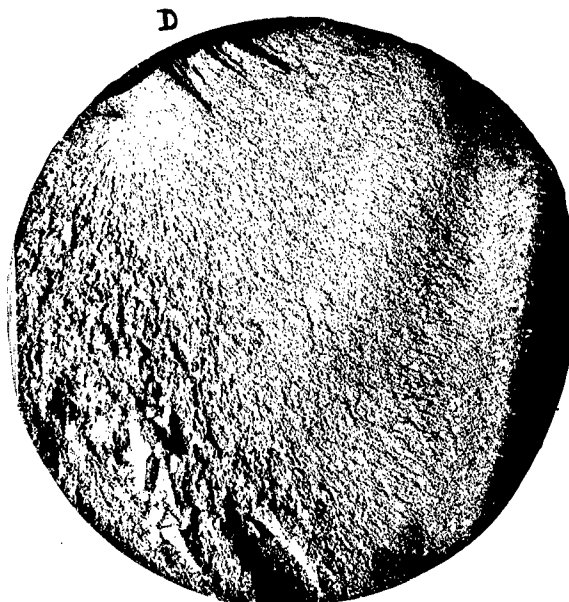
FIGURE 13.2. *Surface of the initial fracture.*

The dark area near D is a crack that occurred during fabrication or heat treatment, and caused the brittle fracture under load. The darkening is due to oxide scale, which shows that the steel was heated to a high temperature after the cracks were formed. $\times 1$.

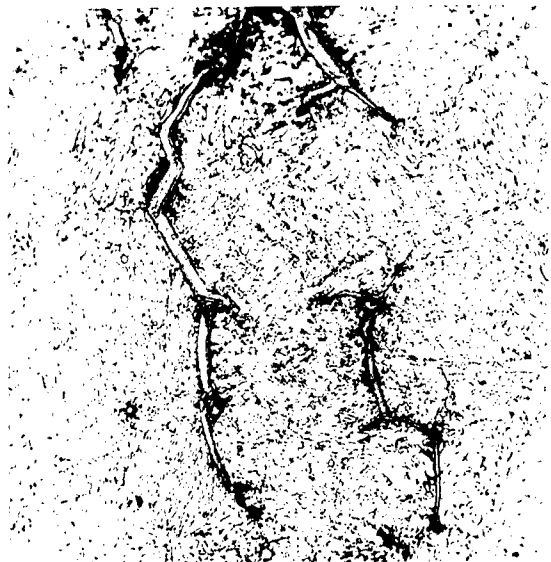
FIGURE 13.3. *Inner end of a crack similar to those which caused the fracture.*

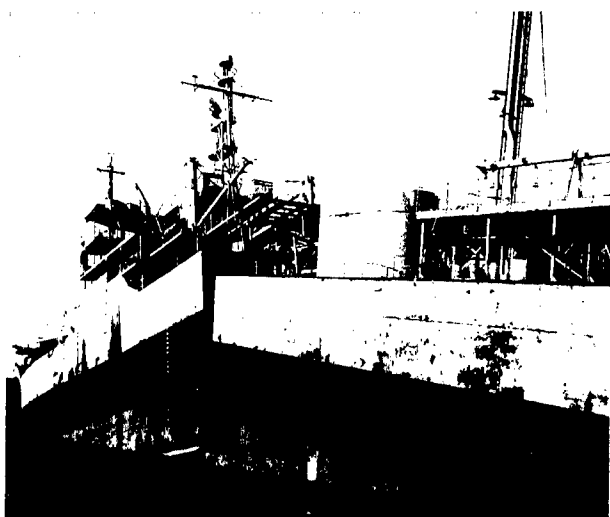
FIGURE 14.1. Tanker that broke in two at dock, viewed from port side.

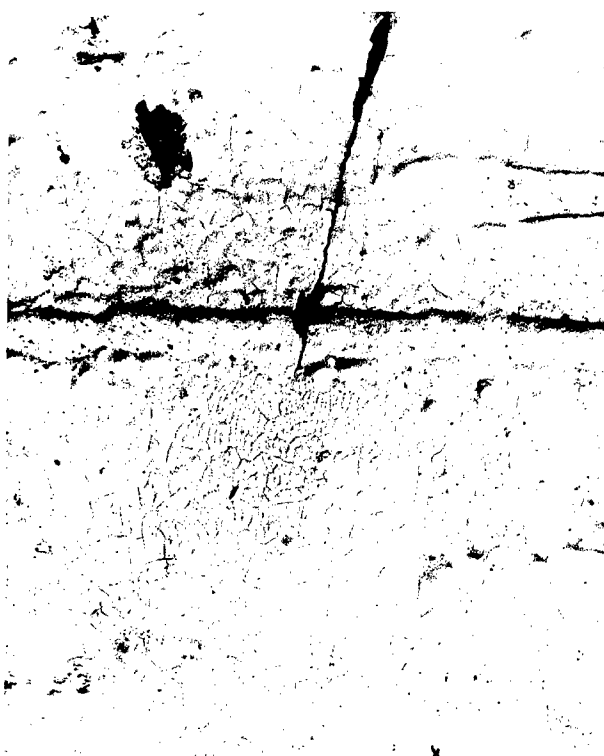
FIGURE 14.3. Area near the end of a fracture.

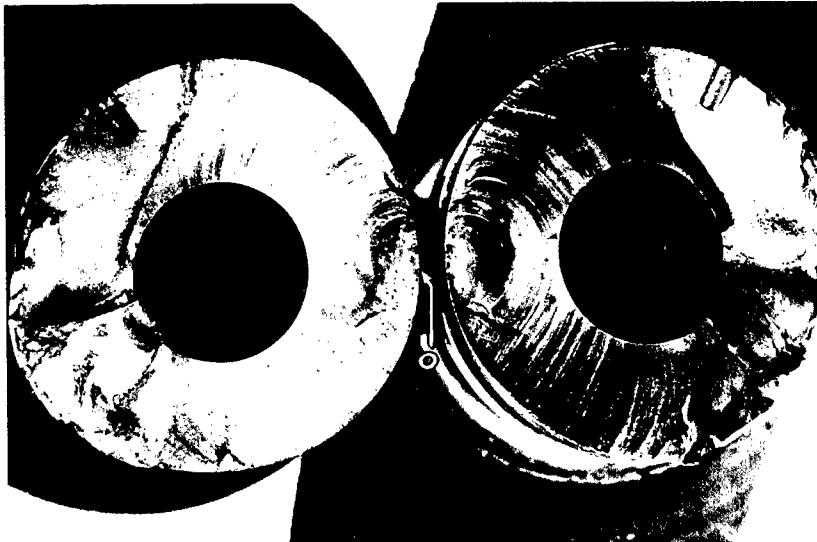
FIGURE 15.3. *Surfaces of the fracture.*

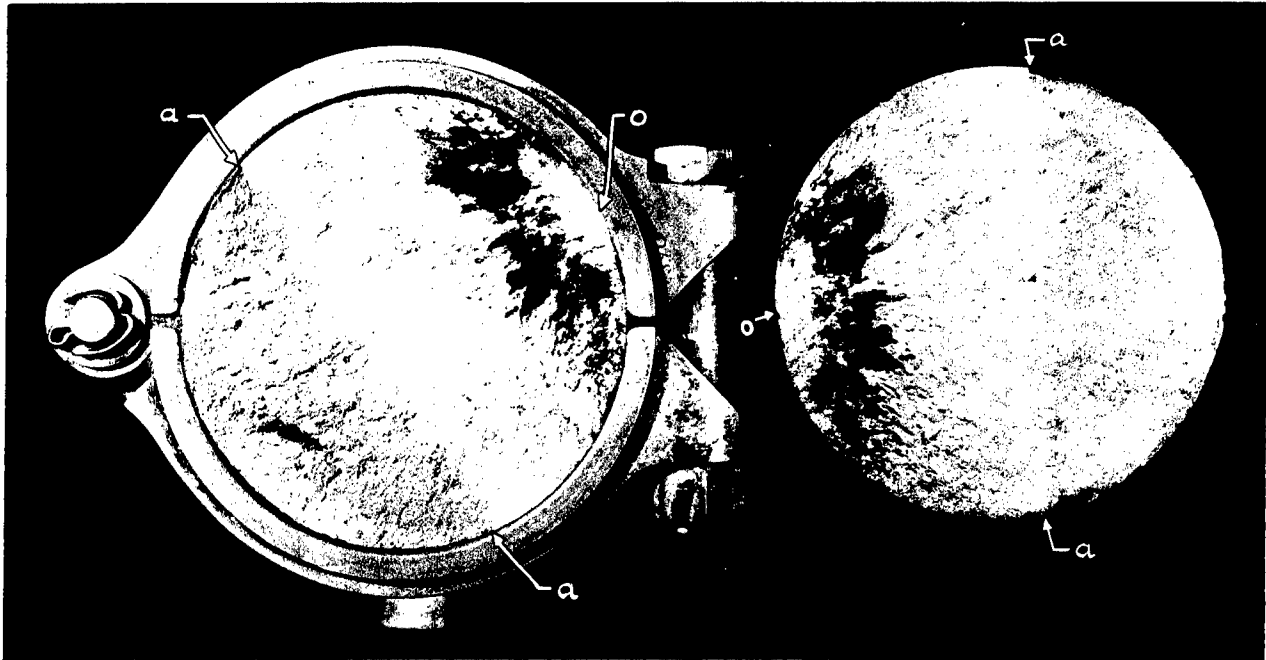
FIGURE 16.1. *Surfaces of the fracture which originated under the hub ring clamp at arrow O.*

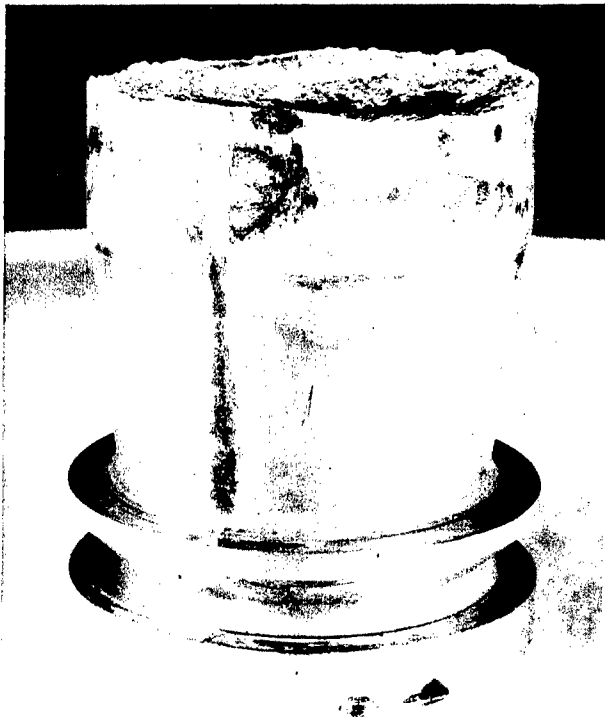
FIGURE 16.2. *Surface of the blade near the origin of the fatigue crack.*

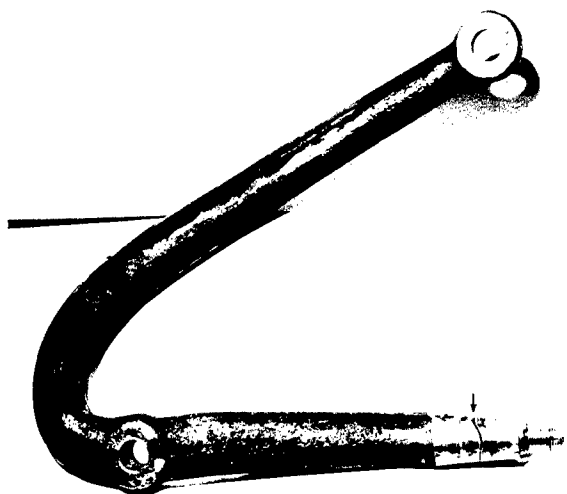
FIGURE 17.1. Broken steering arm from a highway truck. The origin of the primary fatigue crack is indicated by the arrow. $\times 14$.

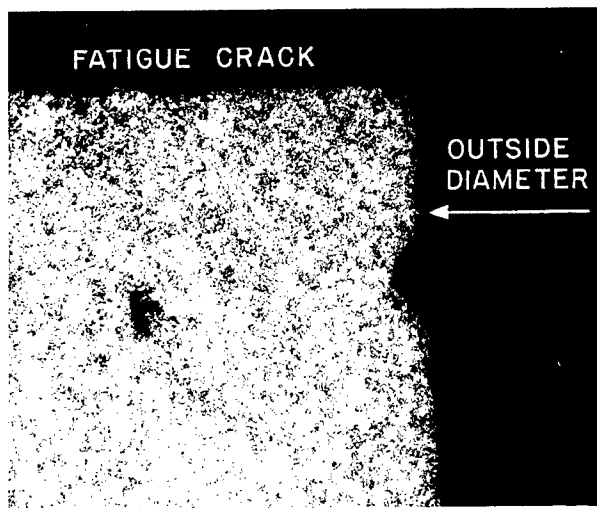
FIGURE 17.3. Longitudinal section of the arm near the origin of the fatigue crack.

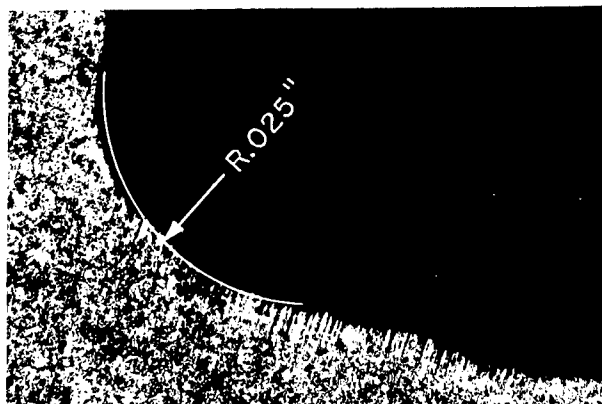
FIGURE 19.2. Section through the intersection of the cut-out and the cylinder, showing the sharp corner with a minimum radius of approximately 0.025 inch. $\times 50$.

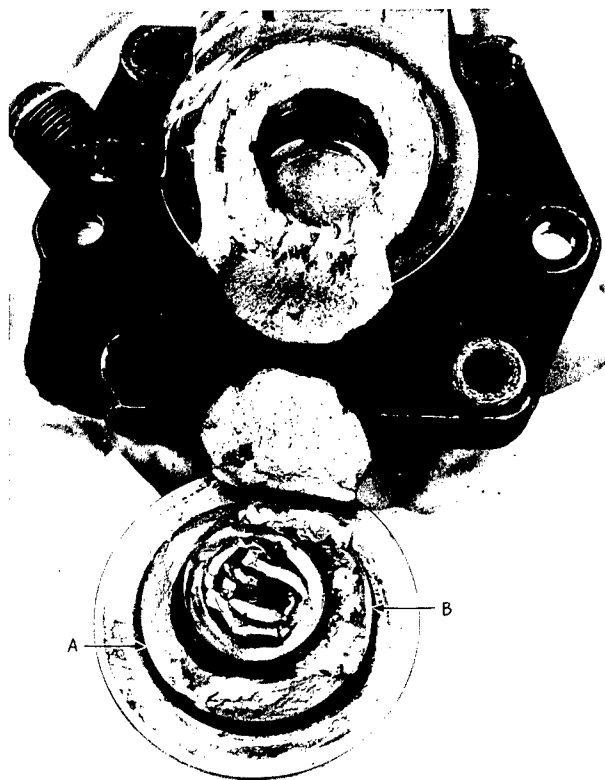
FIGURE 20.1. *Fractured fitting as received.*

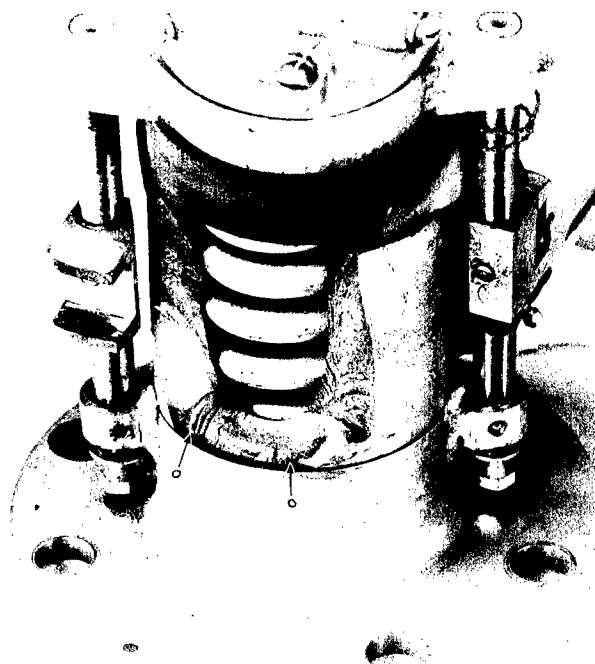
FIGURE 21.1. *Surface of the fracture in the propeller hub where the arm holding one blade broke completely out of the hub.*

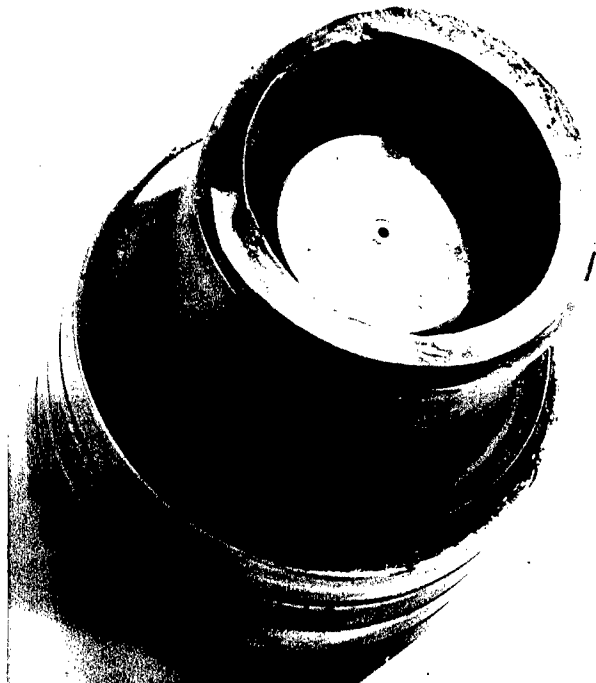
FIGURE 22.1. Hub end of the fractured blade. $\times \frac{1}{2}$.

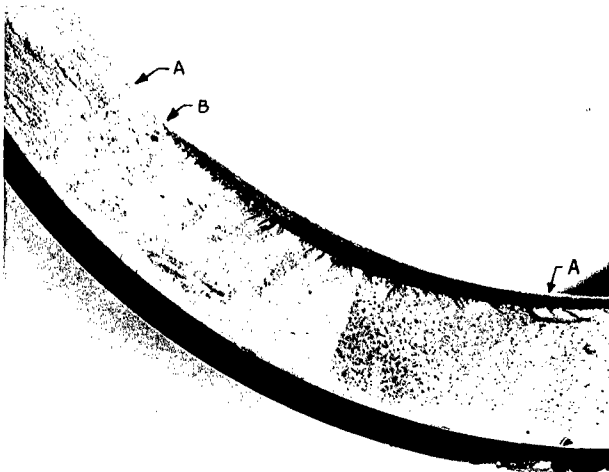
FIGURE 22.2. Fracture surface near the origin of the fatigue crack.

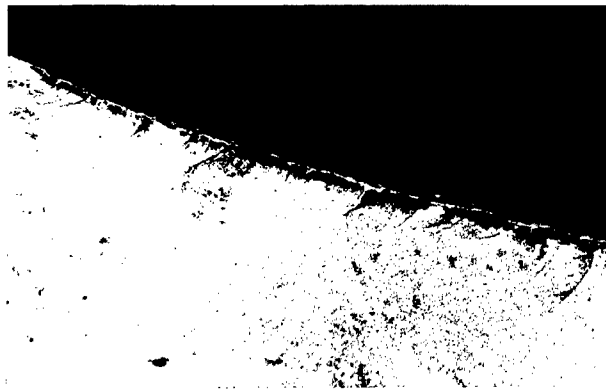
FIGURE 22.3. Surface of the fatigue crack adjacent to the indentation.

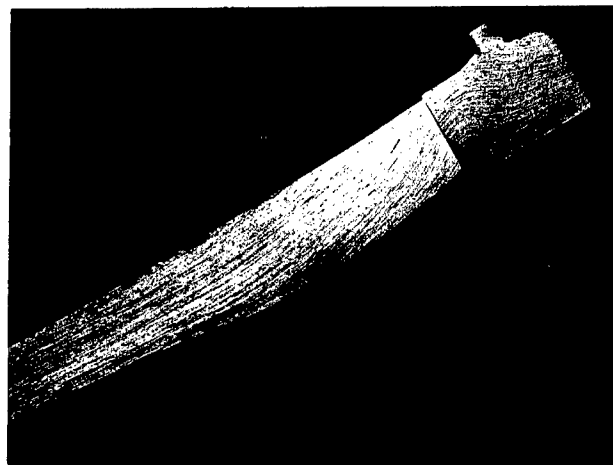
FIGURE 22.4. Longitudinal section of the blade intersecting the fatigue crack.

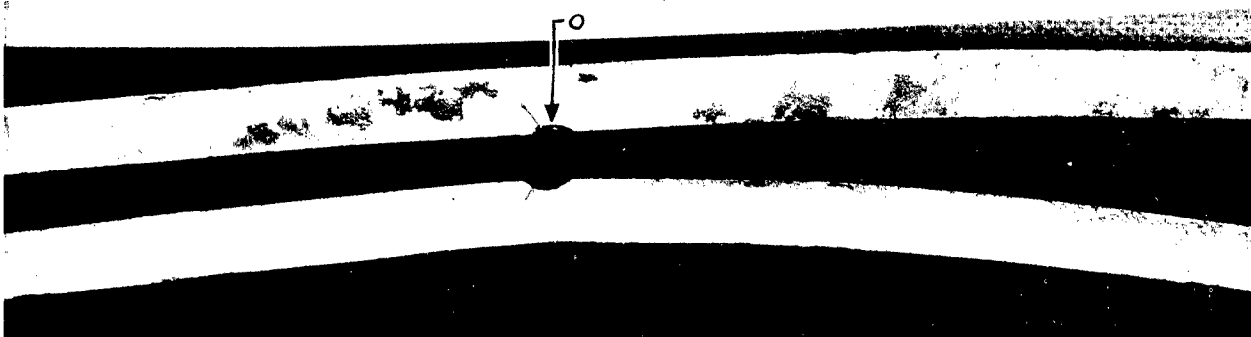
FIGURE 23.2. *Fracture surfaces near the origin of the fatigue crack, arrow O. $\times 3$.*

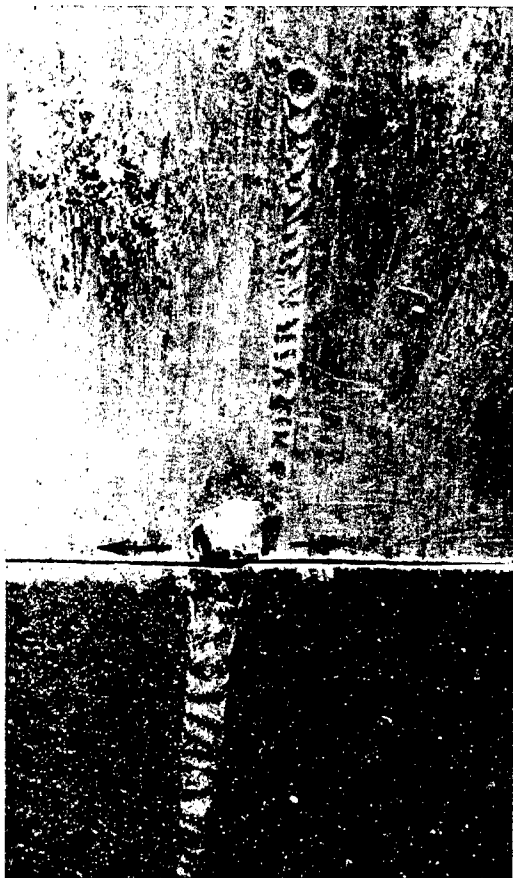
FIGURE 23.4. *Longitudinal section through the defect shown in figure 23.3.*

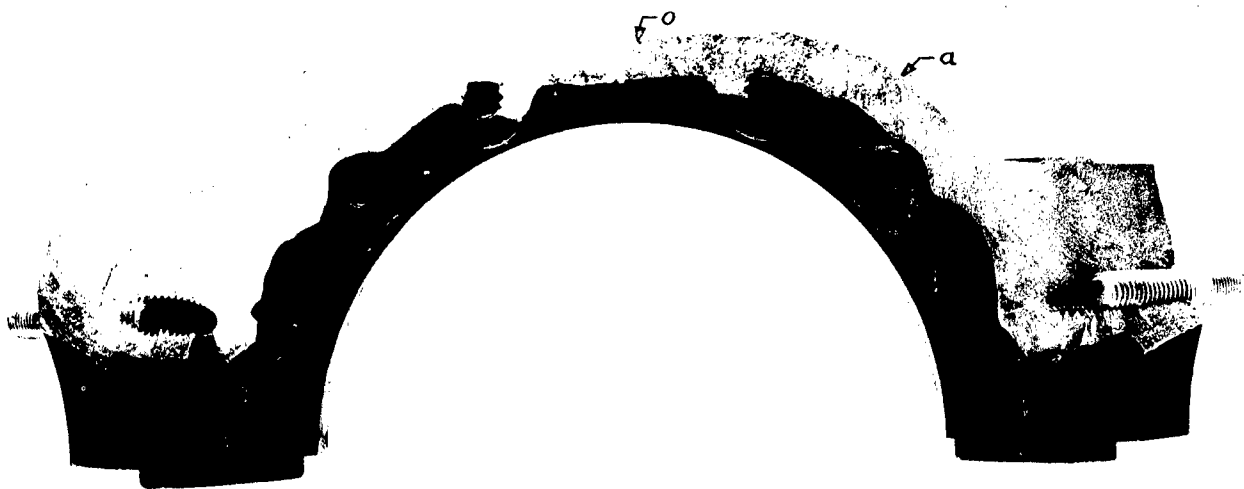
FIGURE 24.1. *Surface of the fracture in the cylinder pad.*

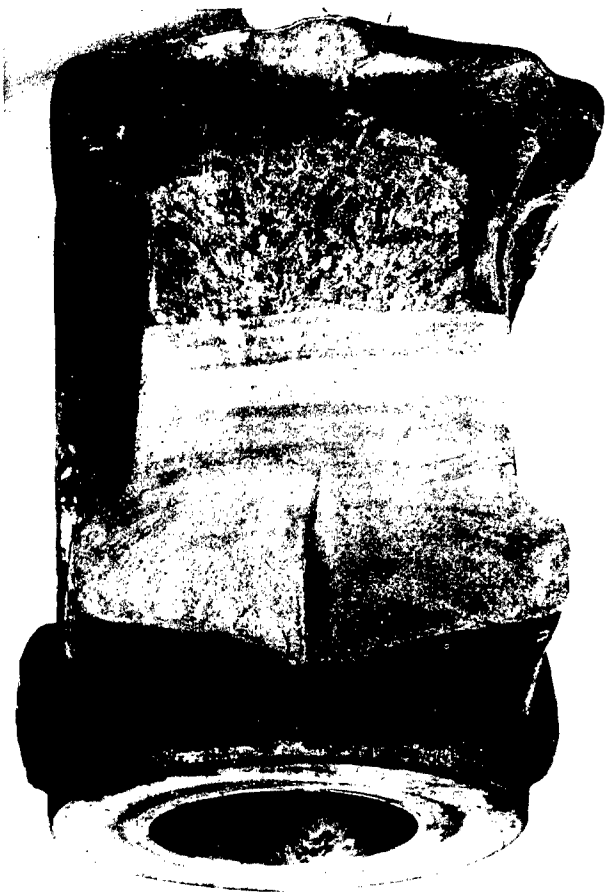
FIGURE 28.1. *Surface of fracture in front axle.*

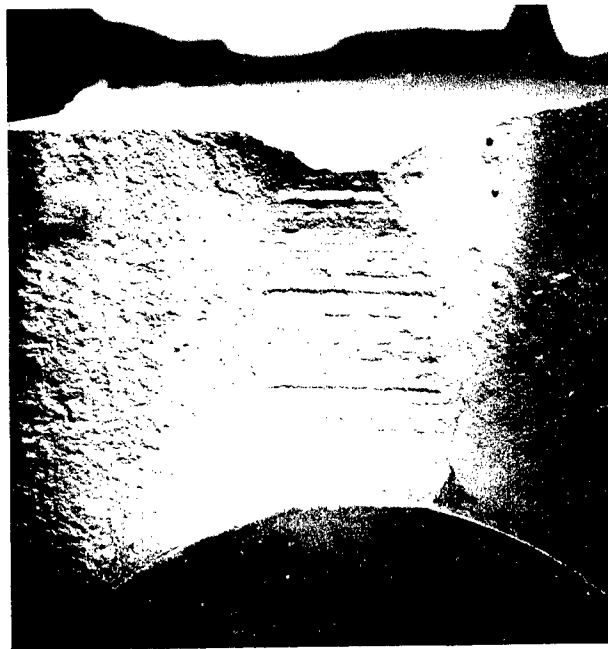
FIGURE 28.2. *Bottom surface of the axle adjacent to the fracture, showing the transverse grooves apparently due to shearing off the forging flash.*

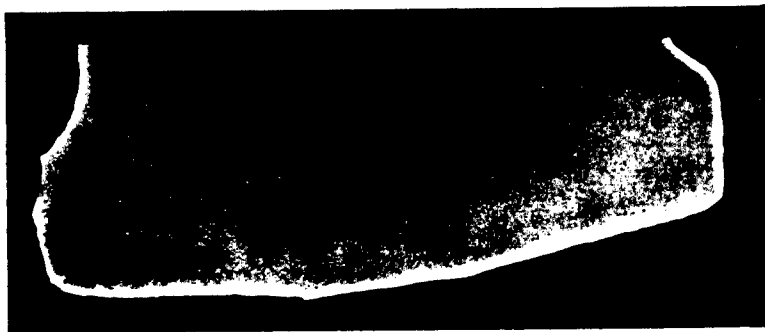
FIGURE 28.3. *Section of the lower part of the axle a short distance from the fracture, showing the extensive decarburization of the surface.*

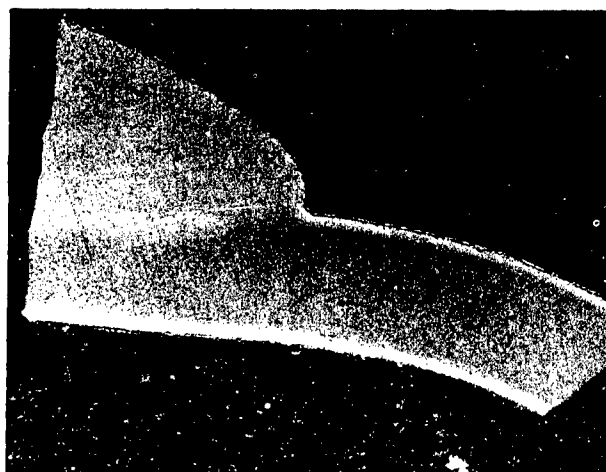
FIGURE 29.2. Transverse section of the tube and weld inboard of the fracture.

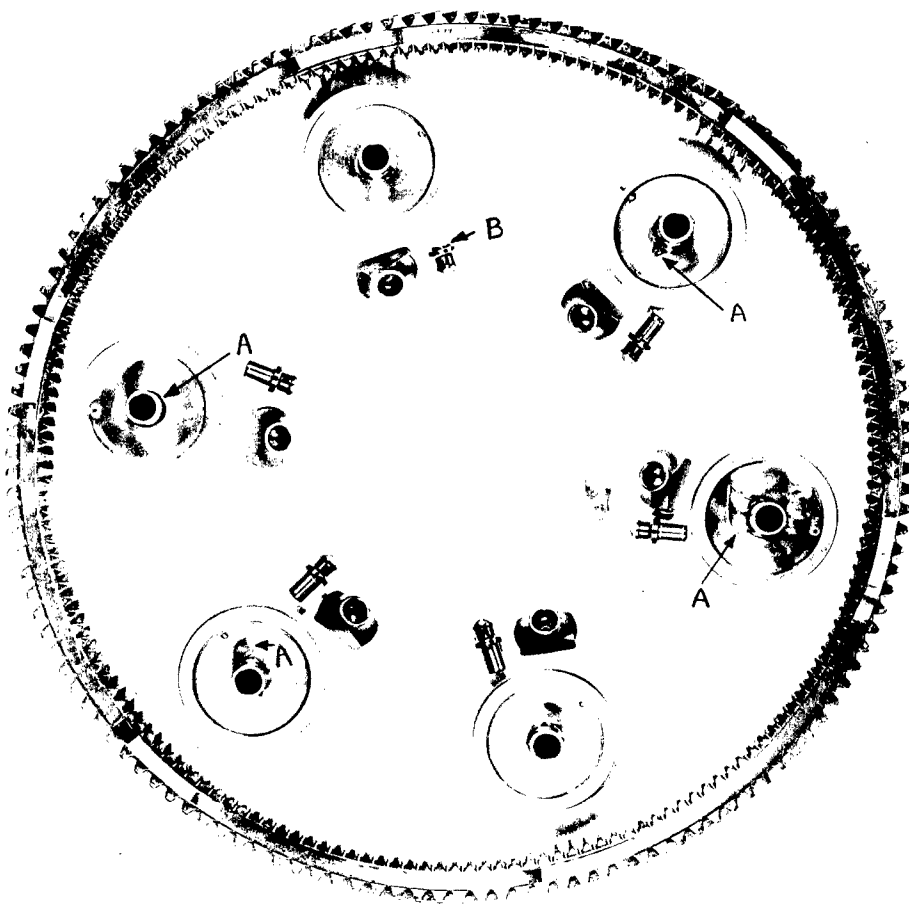
FIGURE 30.1. *Failed torquemeter parts.*

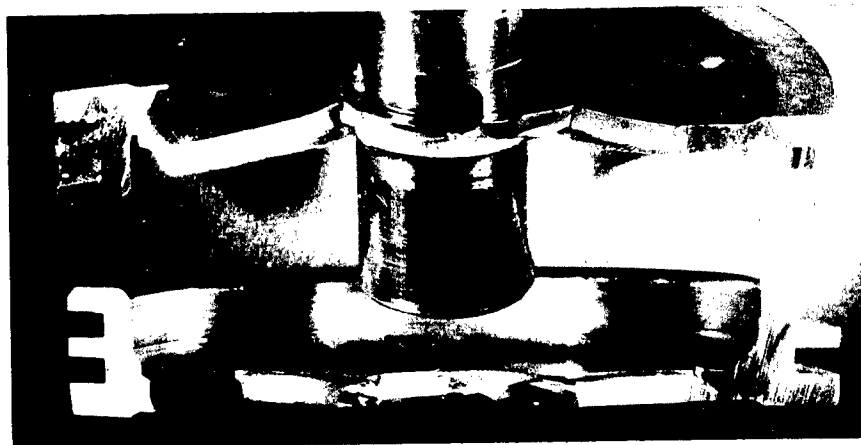
FIGURE 30.2. *Fatigue cracks in one of the pistons.*

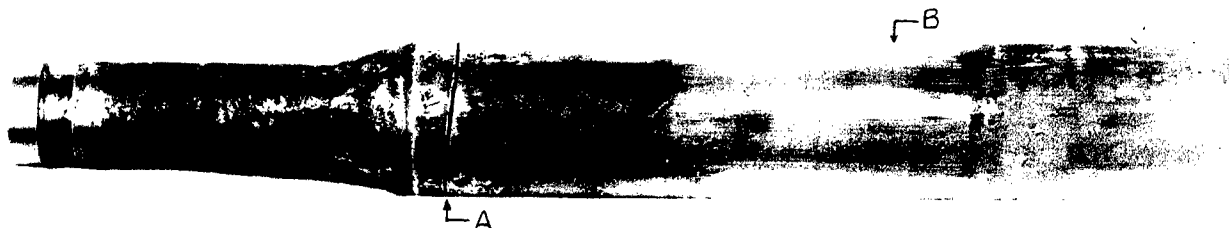
FIGURE 31.1. Pump plunger broken at A, where a crack had been found.

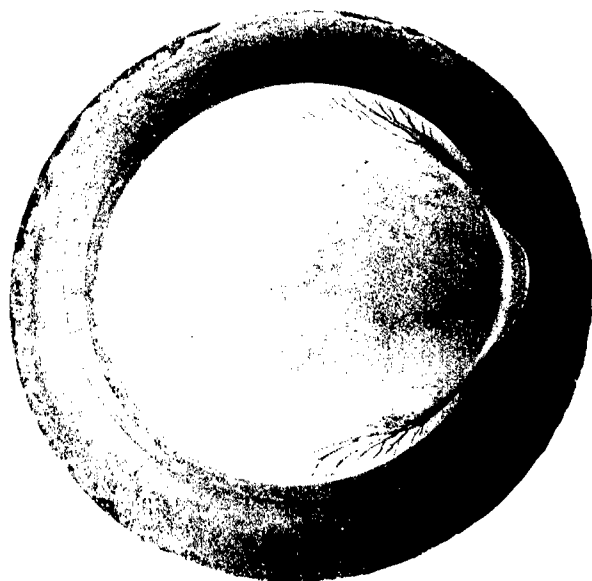
FIGURE 31.2. Surface of the fracture.

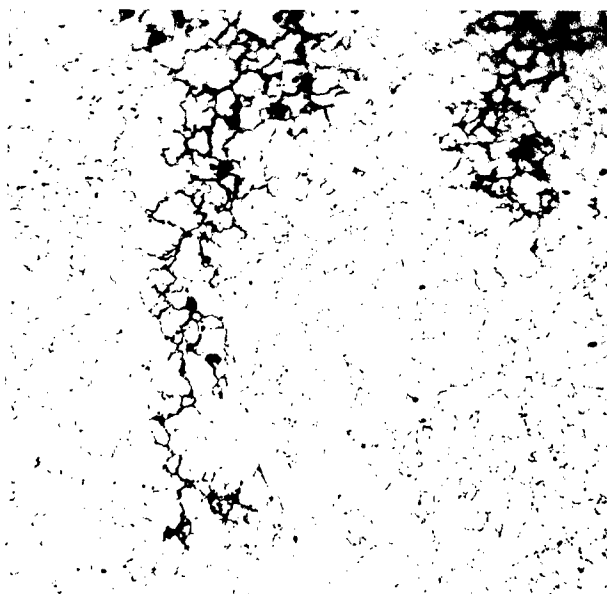
FIGURE 31.3. Transverse section of the plunger near the fatigue fracture.

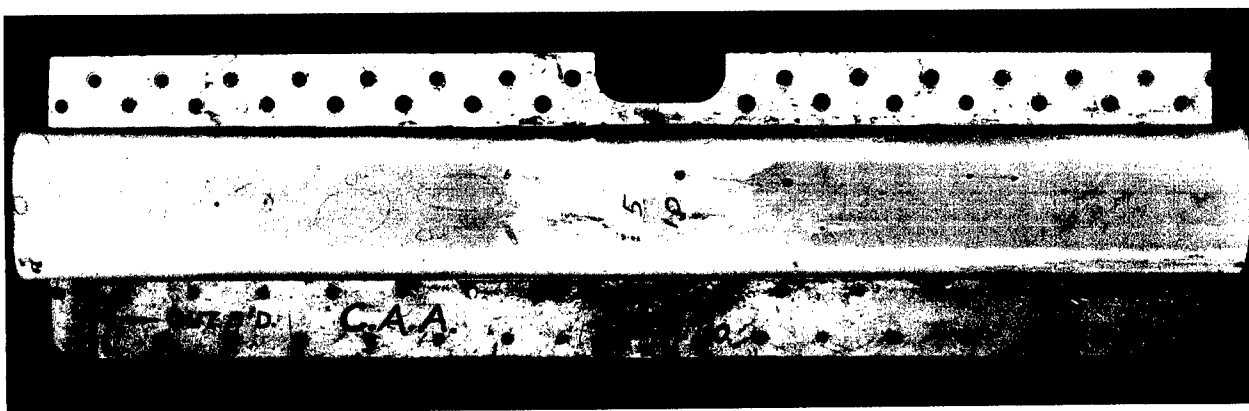
FIGURE 32.1. One of the pieces of cracked spar cap removed from a plane which had been in transoceanic service.

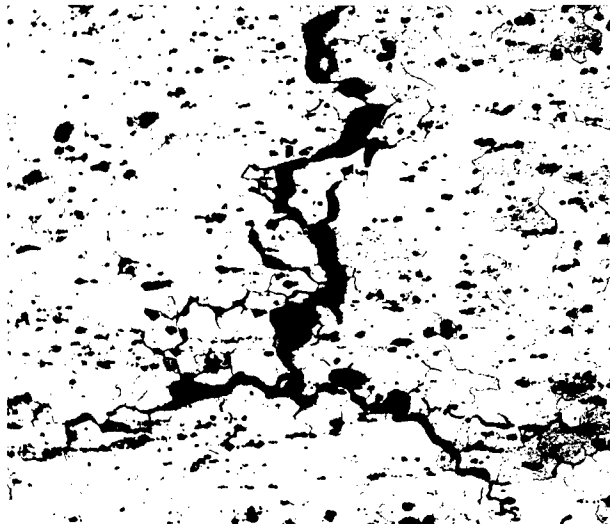
FIGURE 32.4. Photomicrograph showing the intercrystalline path of a crack.

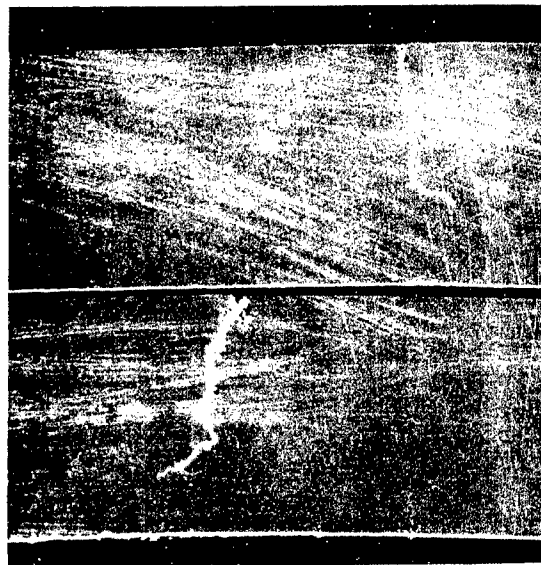
FIGURE 32.3. Cross sections of the tube wall, showing the depth of penetration of the cracks. $\times 7$.

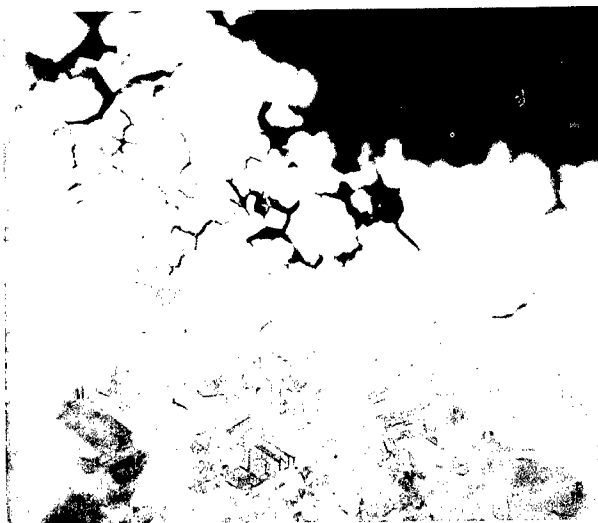
FIGURE 34.2. *Longitudinal section near the fracture, showing the intercrystalline cracks typical of stress-corrosion failures.*

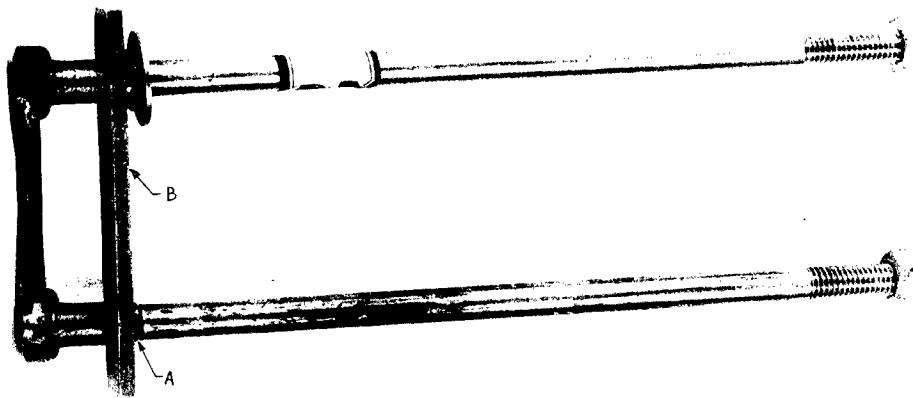
FIGURE 34.1. *Window washer's anchor with one bolt broken at arrow A.*

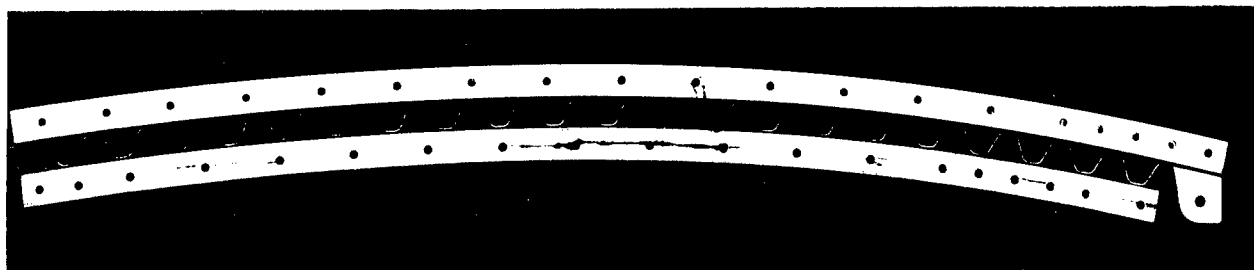
FIGURE 35.1. Cracks in the lower angle as revealed by a dye penetrant inspection method. The longitudinal cracks were caused by a tensile stress in the transverse direction. $\times \frac{1}{8}$.

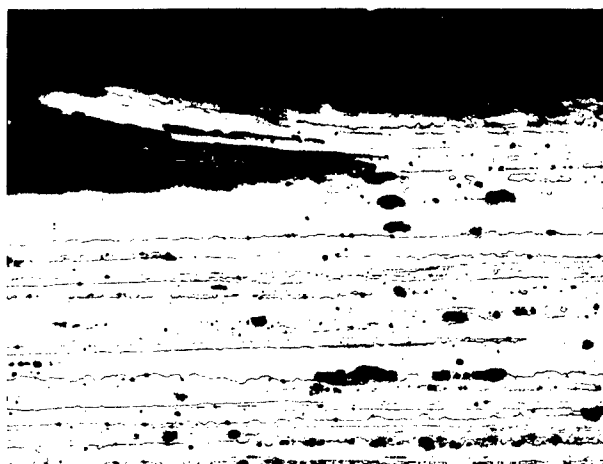
FIGURE 35.3. Longitudinal section perpendicular to the fracture shown in figure 35.2.
